Forgotten Wrecks
of the
First World War

Barge *Wessex* and its Littlehampton Construction Yard

Barge Wessex,
River Hamble, Hampshire, and its
construction yard at Littlehampton,
West Sussex

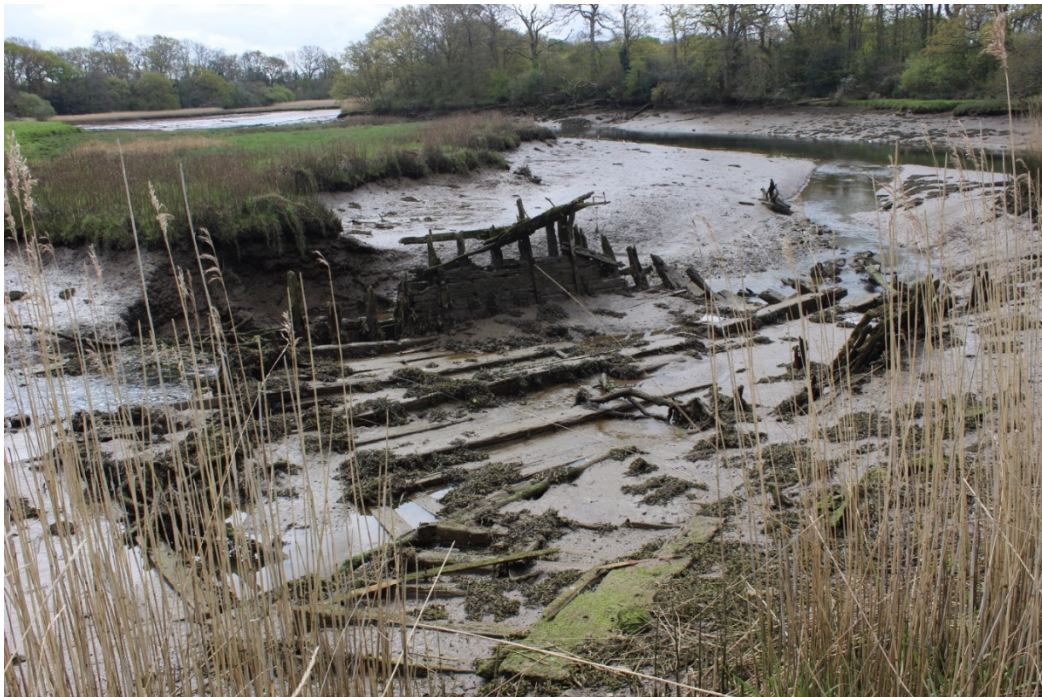
FIGURE 2: HULK OF THE BARGE *WESSEX* SITTING IN A TRIBUTARY OFF THE MAIN HAMBLE RIVER.

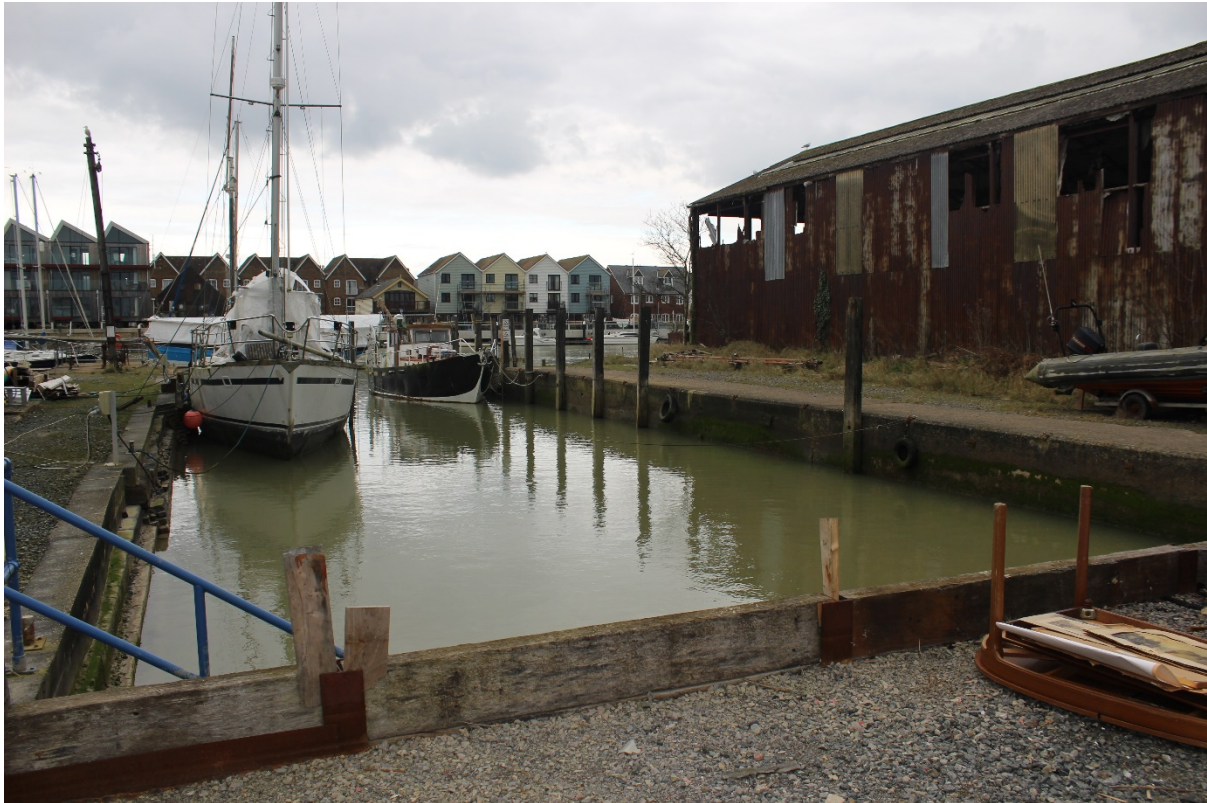
FIGURE 3: THE OLD DOCK AT LITTLEHAMPTON, FORMERLY HARVEY'S SHIPBUILDERS

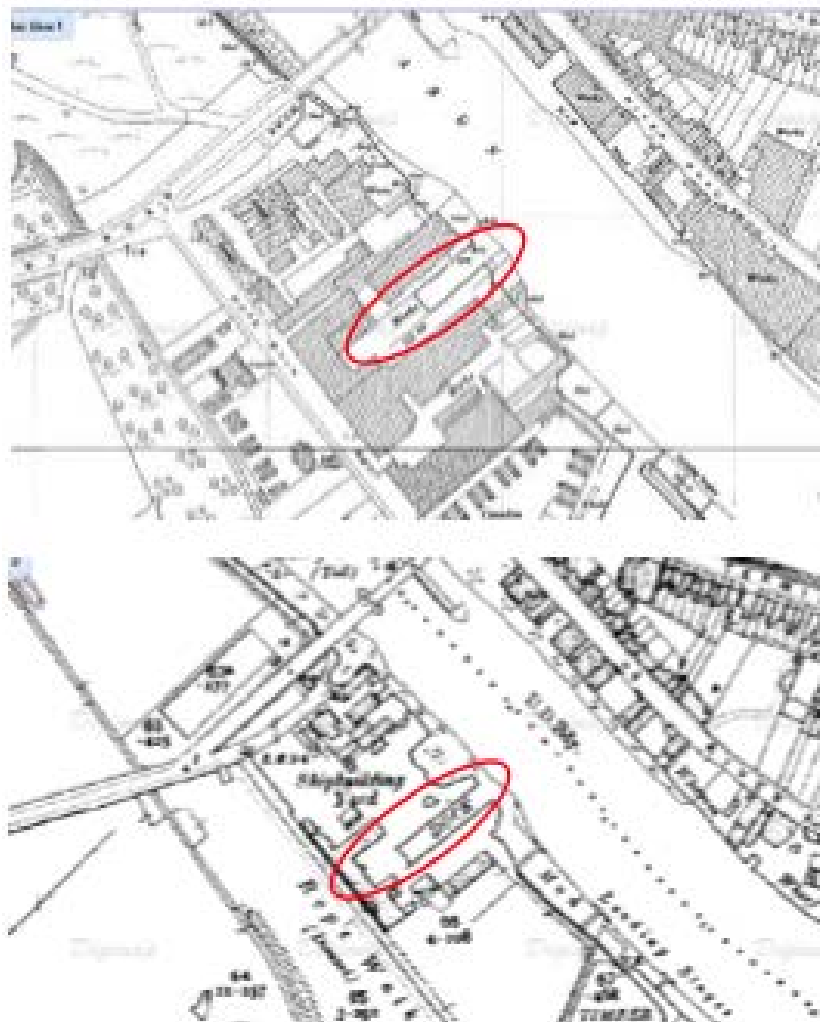
FIGURE 5: SHIPBUILDING DOCK THROUGH TIME. TOP: THE HISTORIC DOCK IN THE 1950S; BOTTOM: 1910S LOCATION, APPROXIMATELY CONTEMPORARY WITH CONSTRUCTION OF THE WESSEX

Historic OS maps were crucial in the identification of the location of Harvey's shipbuilders at Littlehampton and their use allowed the site to be accurately located on the west side of the river Arun near to the old Rope Walk (Figure 5). The dock is now used to moor boats and no boat building occurs on site, however, the remains of the old boat building warehouse are still extant and the historic buildings remain intact (Figures 3 and 6).

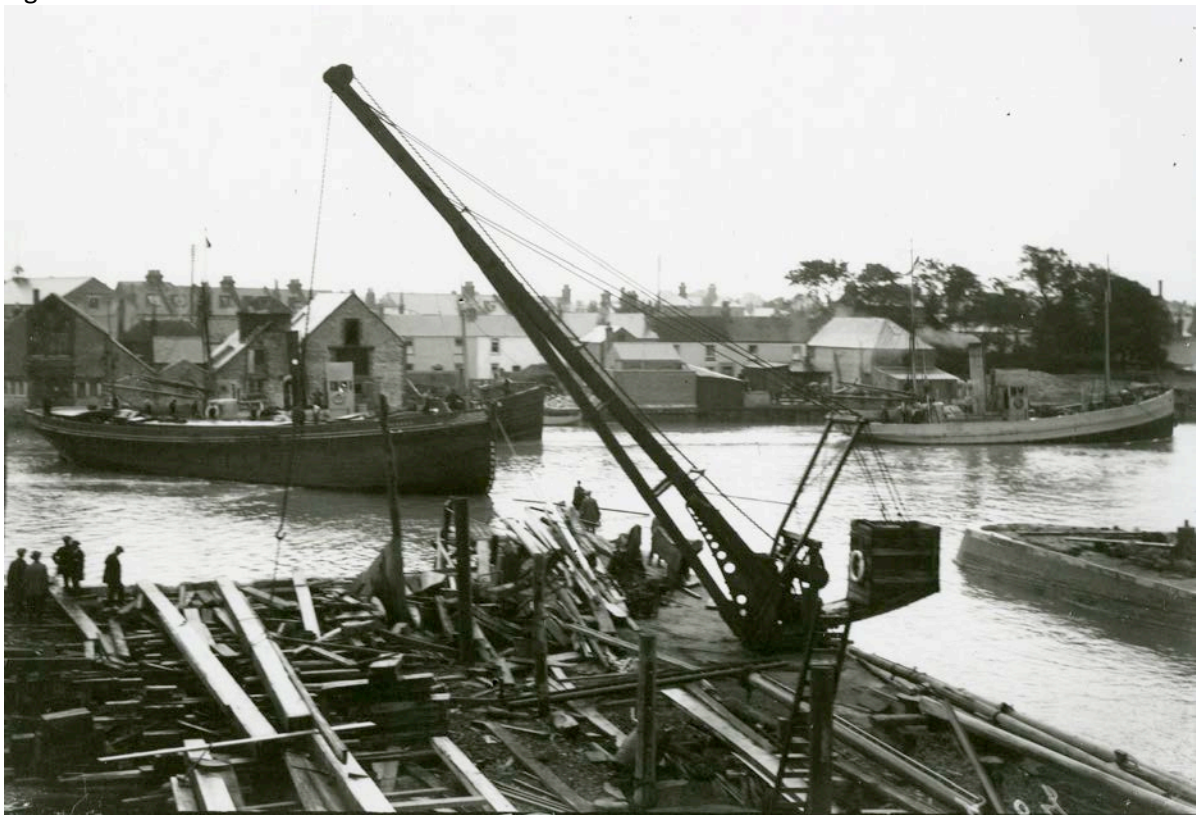
FIGURE 7: THE LAUNCH OF THE BARGE WESSEX IN 1918 FROM HARVEY'S AT LITTLEHAMPTON. NOTE THE CRANE TO THE LEFT SIDE OF THE DOCK, WHICH CAN BE SEEN IN FIGURE 3. (COURTESY OF LITTLEHAMPTON MUSEUM ARCHIVE)

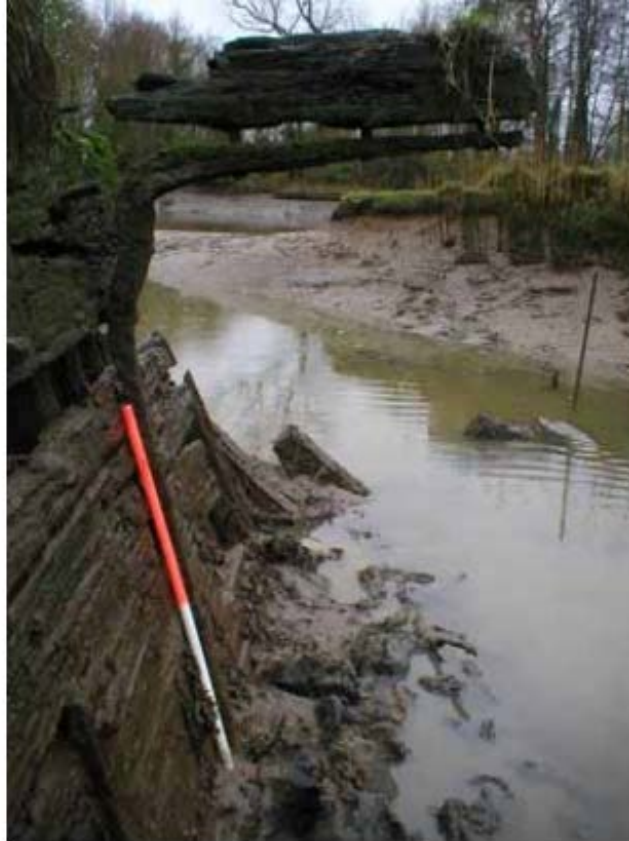
FIGURE 8: 2007 IMAGE SHOWING THE UPSTANDING STARBOARD SIDE OF THE WESSEX WITH AN IRON KNEE AND THE REMAINS OF DECKING ABOVE

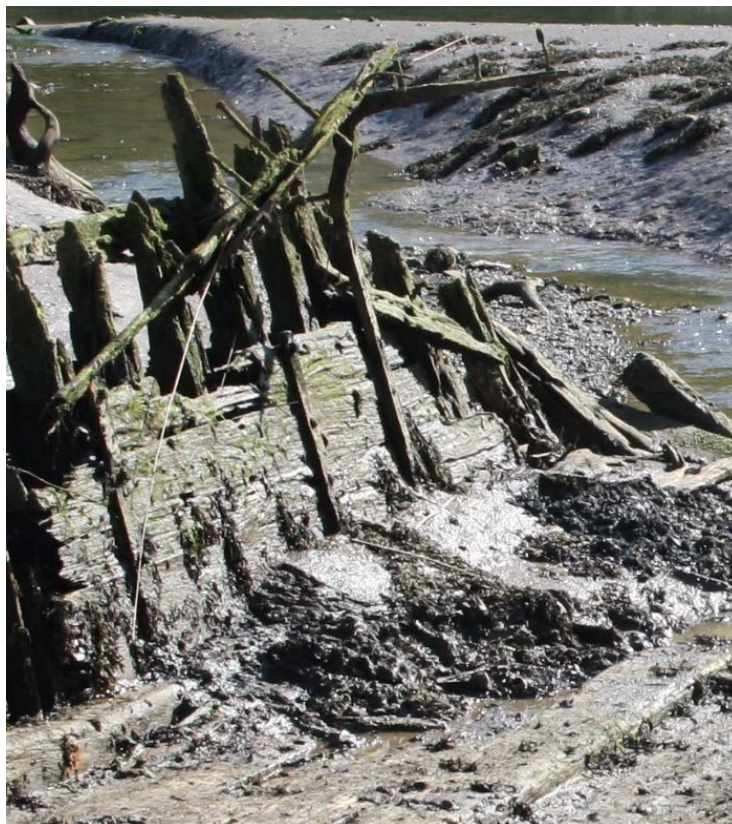
Seven log sheets were completed over the course of the low tide (approximately 2 hours), documenting the upstanding starboard side with a profile through the vessel, the exposed planking and general features of note. The starboard side was the main area of loss, with some of the frames and planking now eroded away.

FIGURE 9: THE STARBOARD SIDE IN 2016, SHOWING THE CHANGES SINCE 2007: MUCH OF THE PLANKING HAS BEEN LOST AND THE DECKING THAT PREVIOUSLY RESTED ON THE KNEE HAS ALSO GONE.

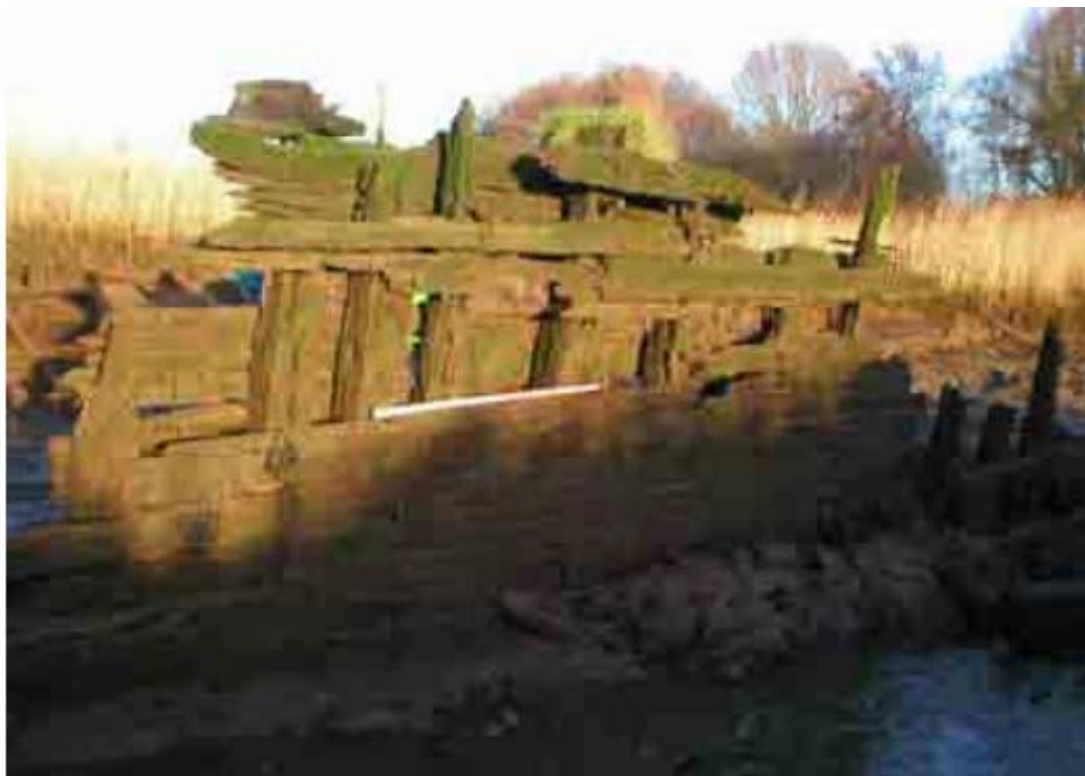
FIGURE 10: OUTER VIEW OF THE STARBOARD SIDE OF THE WESSEX IN 2007

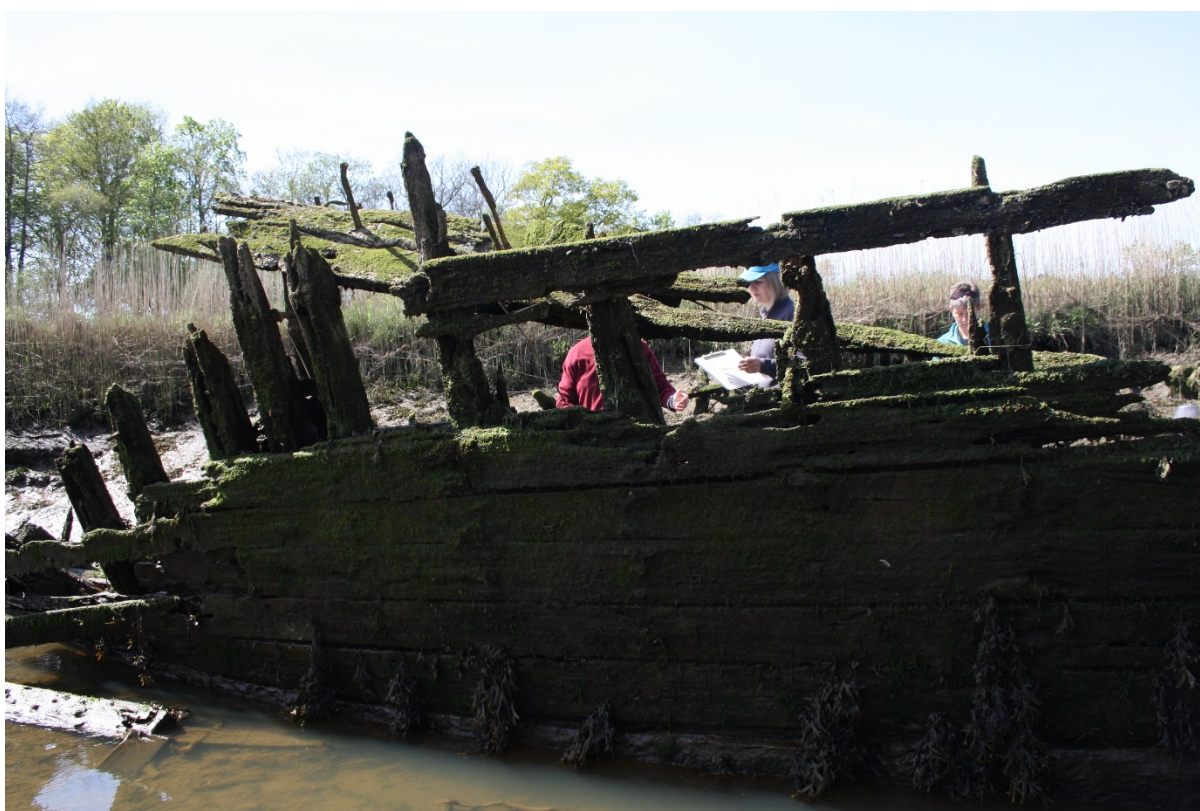
FIGURE 11: OUTER VIEW OF THE STARBOARD SIDE OF THE WESSEX IN 2016, DEMONSTRATING THE LOSS TO THE INNER AND OUTER PLANKING AND THE FRAMES.

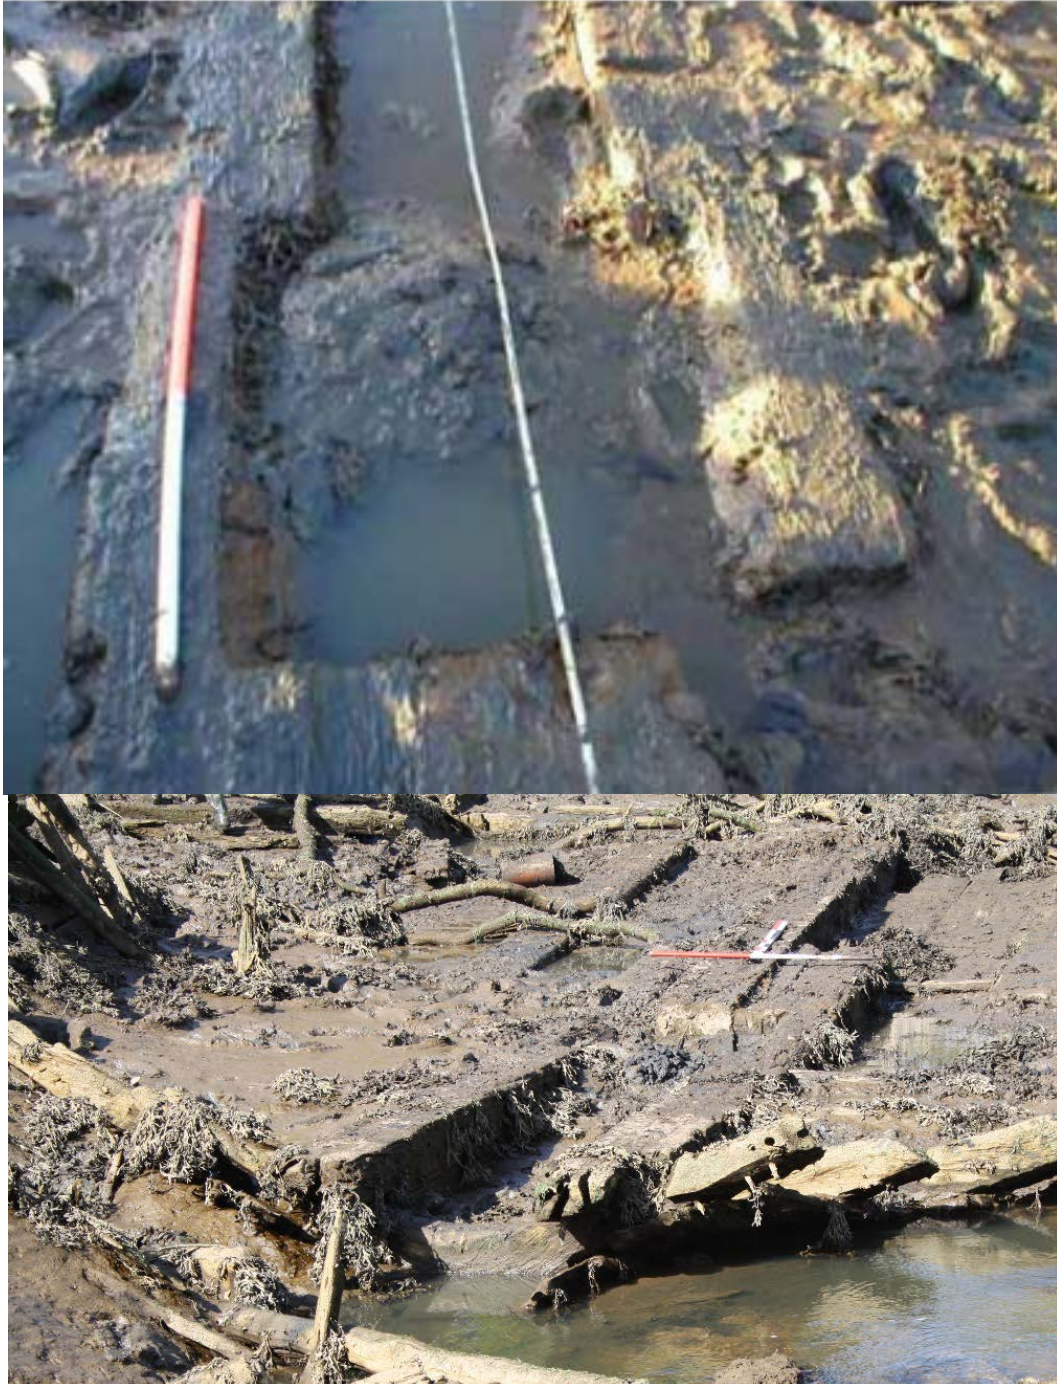
Elements of the vessel's construction were reinterpreted during the 2016 visit. It had previously been thought that the large rectangular hollow towards the aft end of the central keelson was a mast step. The size of this (approximately 1m long and 0.6m wide) makes this unlikely. Its relationship to a long passageway with a concave base moving out to the stern of the vessel indicates that this could instead be the location of the engine, with the passageway being where the prop-shaft sat (Figure 12).

FIGURE 12: TOP IMAGE SHOWING THE DIMENSIONS OF THE POSSIBLE ENGINE HOLE WITH THE POSSIBLE PROP SHAFT MOVING OUT TO THE TOP OF THE PHOTO (IMAGE FROM 2007), WITH THE BOTTOM IMAGE LOOKING TOWARDS THE POSSIBLE PROP SHAFT, SHOWING ITS CONCAVE BASE AND EXTENSION TO THE STERN OF THE VESSEL.

The 2016 survey identified what was previously believed to be a mast step as an engine box and run for the prop shaft. In research undertaken by Moss et al (2007) a superimposed plan and profile of a boom coastal barge from a similar date of construction and of very similar tonnage and proportions was presented to give context to the site remains (See Figures 17 and 18). Recent research has also identified a photograph of the barge *Wessex* in 1918 (See Figure 19), which demonstrates there was

a mizzen mast in a similar position to where an engine box may be located. The presence of a prop shaft run would suggest this particular feature is an engine box, however, it is clear the mizzen mast would have been located close to this position.

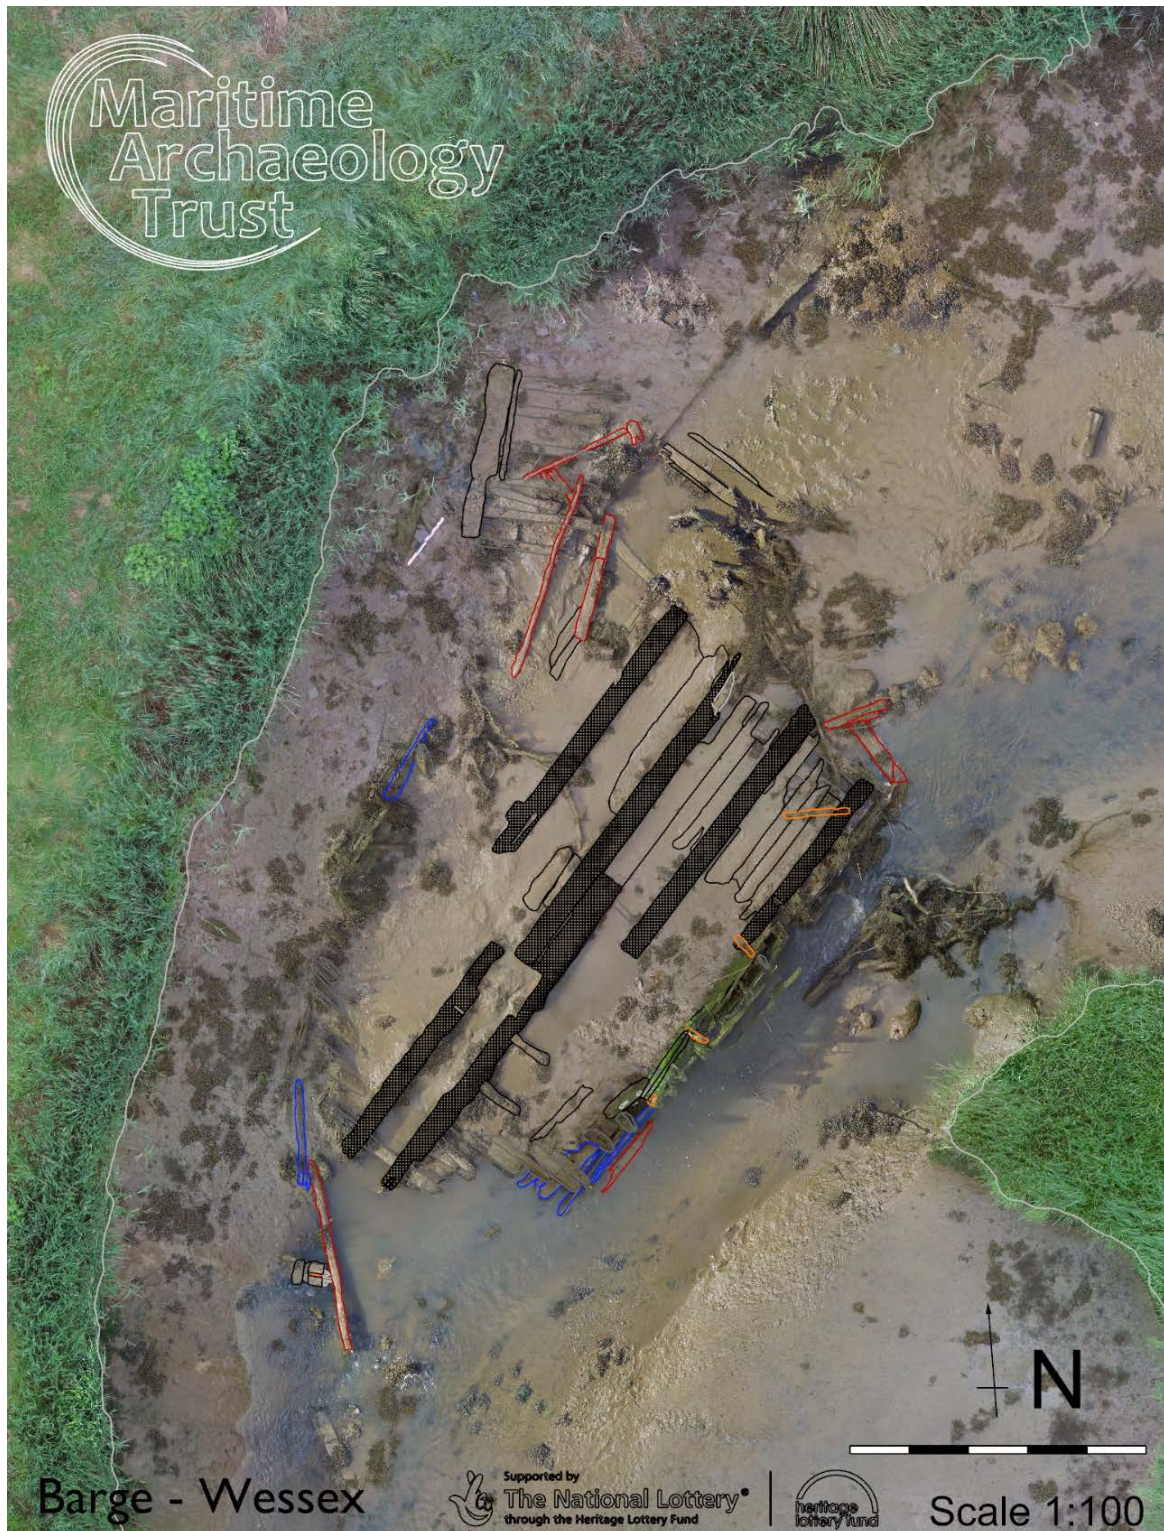
By collecting a series of aerial photographs an accurate orthographic image was created, this was used to develop an updated plan of the site. Figure 15 below shows the comparison of the two site plans which demonstrates a largely similar condition other than the losses of structure mentioned above.

FIGURE 15: ORTHOMOSAIC GENERATED SITE PLAN FOR THE BARGE WESSEX, SHOWING CHANGES ON THE SITE BETWEEN 2007 AND 2016.

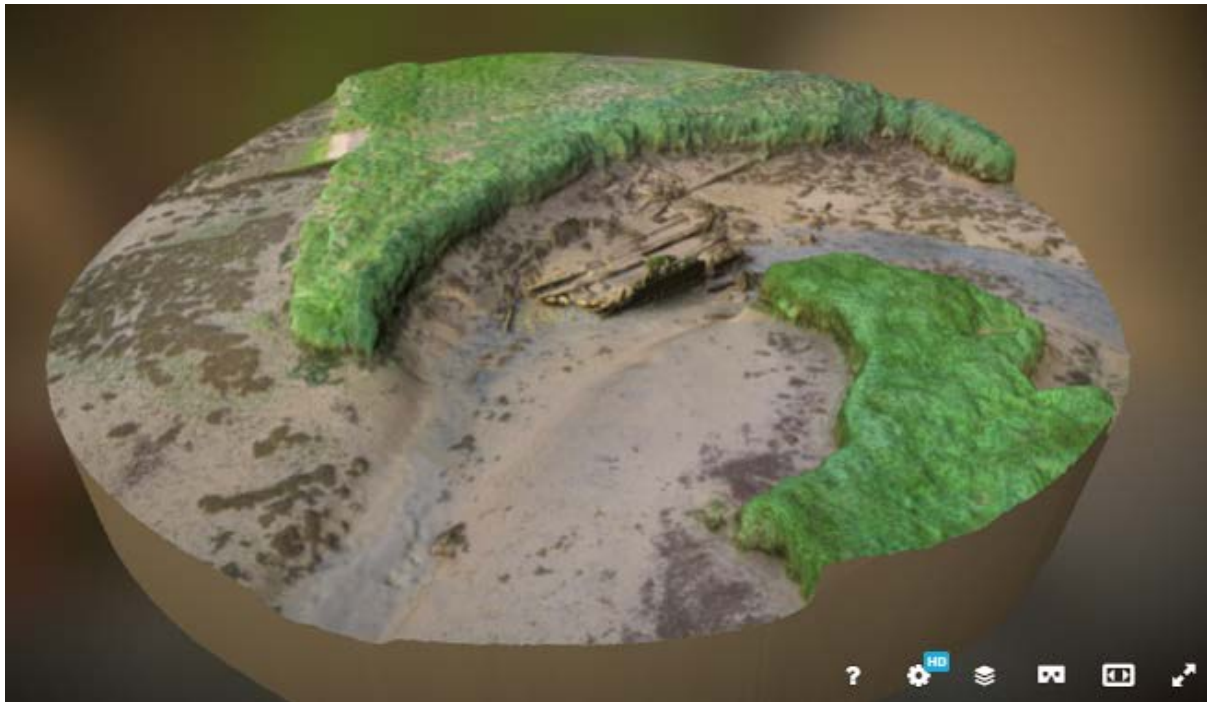
Photogrammetry was used to capture of the geometry of the site using still images that were processed in the software package Agisoft to create a 3D model. Known reference points were then used to refine the model during analysis and reality capture was used to create texture and more accurate geometry.

FIGURE 16: EXAMPLE IMAGE OF 3D MODEL OF THE BARGE WESSEX

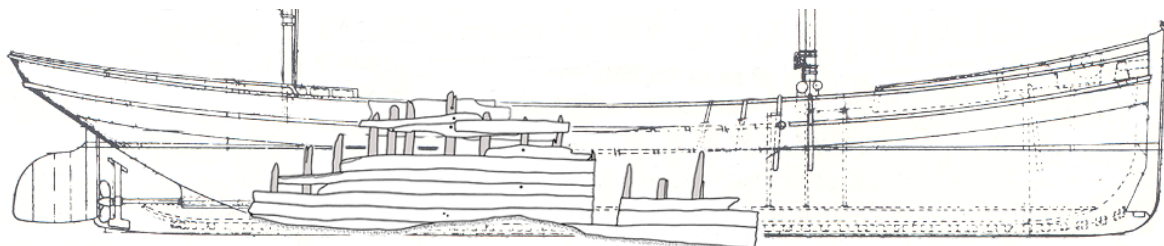
FIGURE 18: PLAN AND PROFILE INTERPRETATIONS: DA SILVA, KIM, BURT AND MOSS (MOSS ET AL)

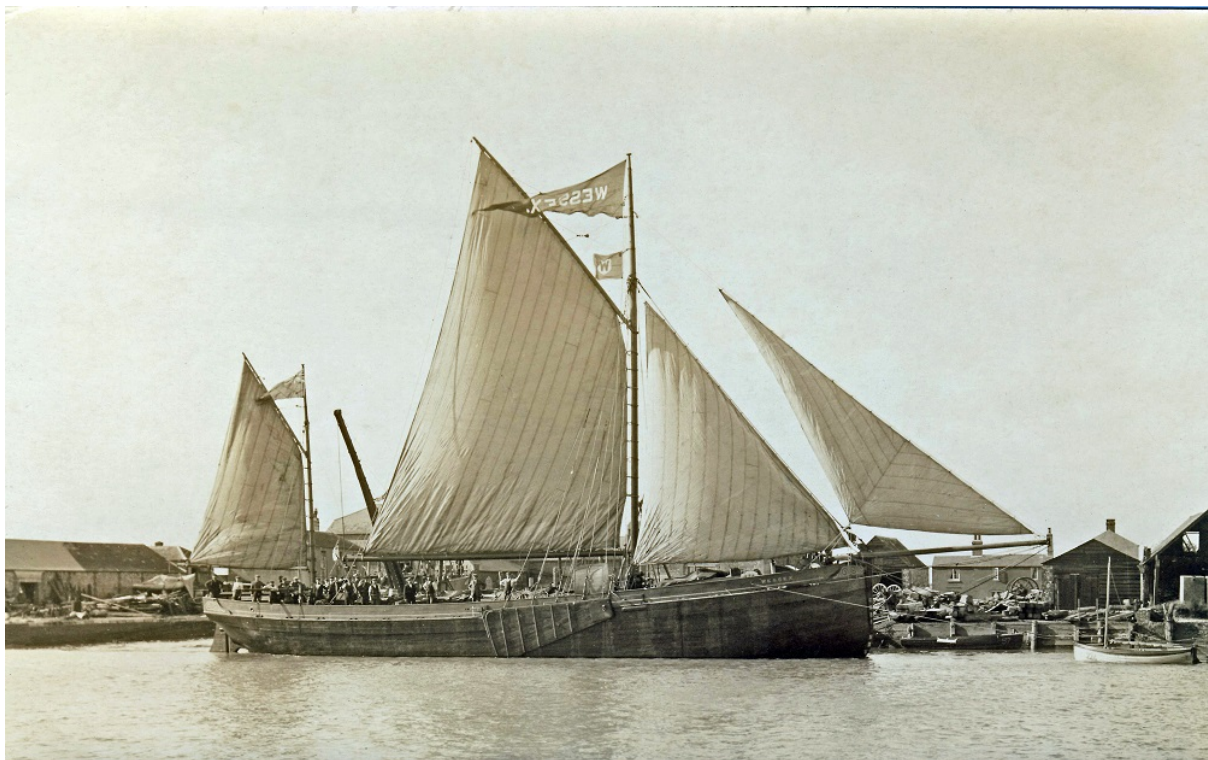
FIGURE 19: COPY OF A FRANK SPRY POSTCARD SHOWING THE *WESSEX* IN 1918 (KINDLY SUPPLIED BY ANTHONY PRATT)
