Forgotten Wrecks of the First World War

Pinnacle 704 (FL7) Site Report

Steam Pinnacle 704 (FL7)
Site Report

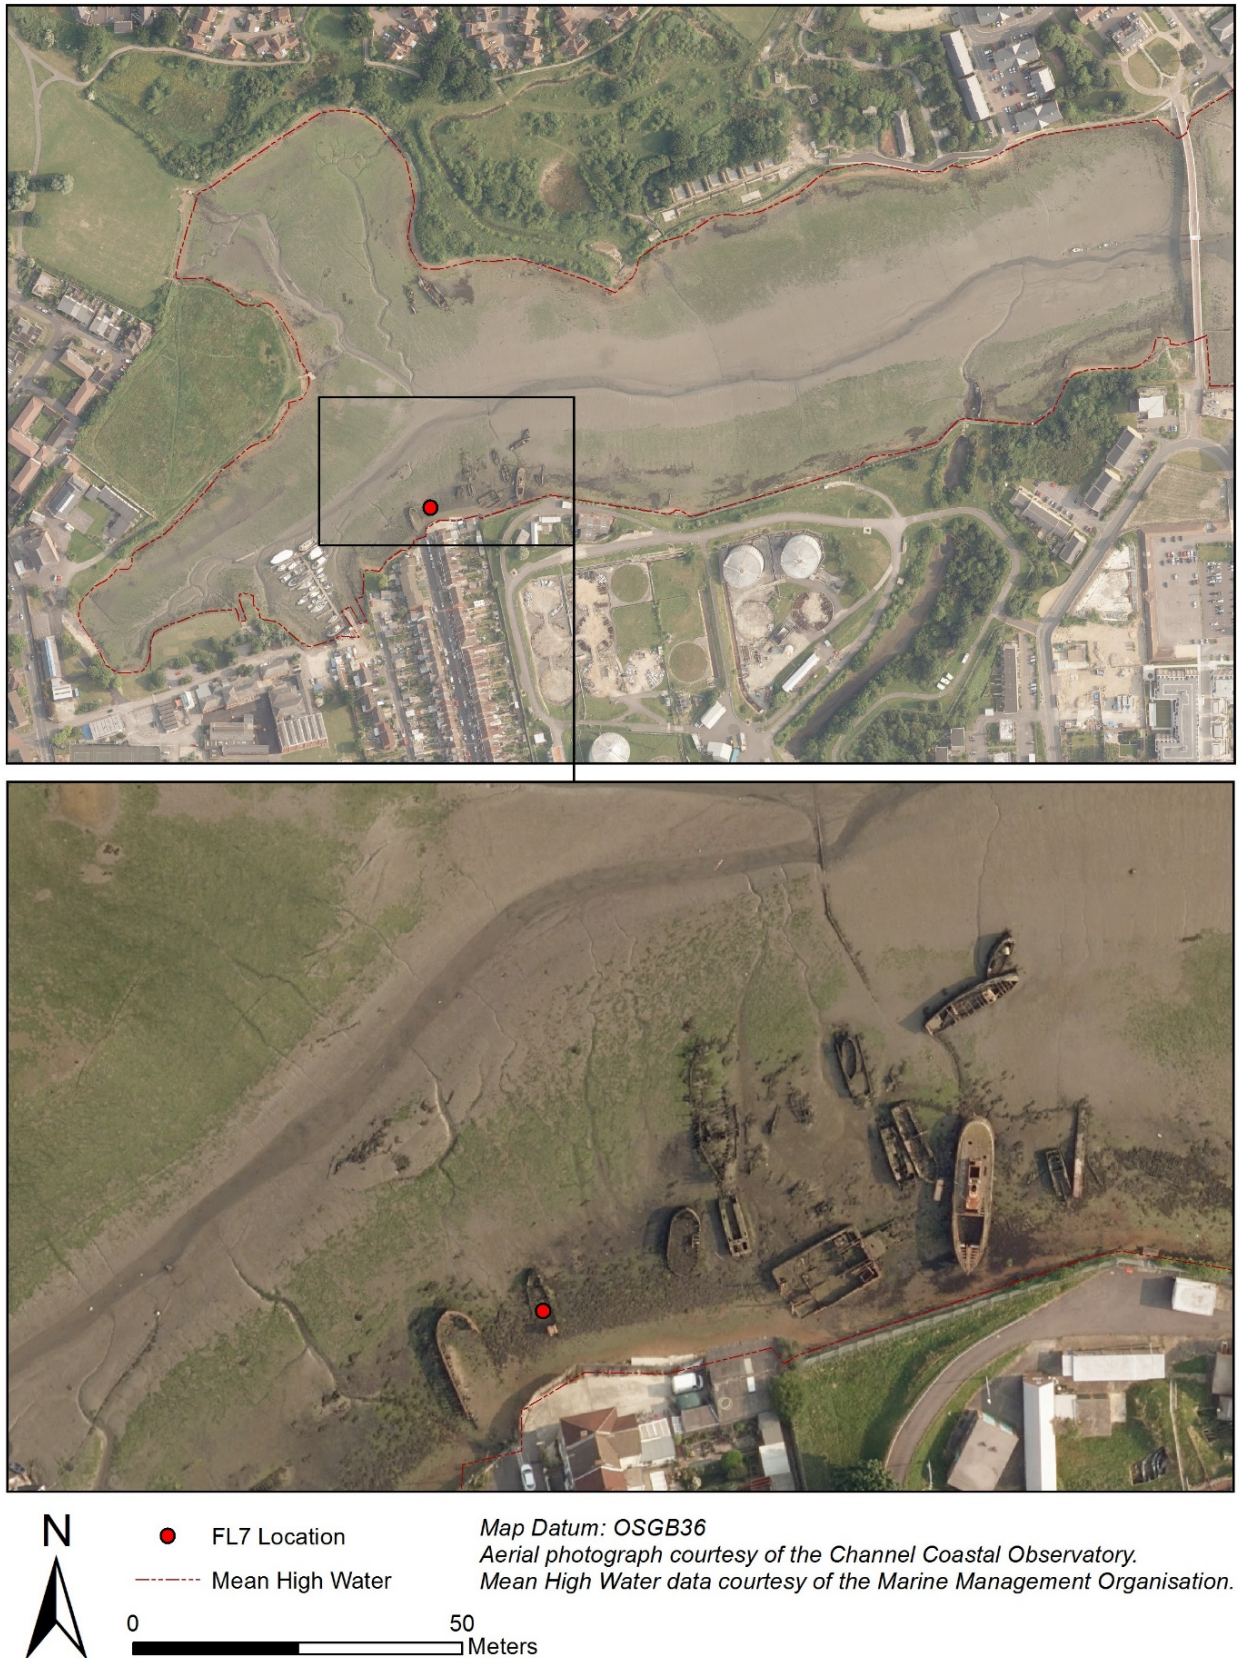
FIGURE 2: LOCATION OF FL7 WITHIN FORTON LAKE, AT THE WESTERN END OF THE MAIN COLLECTION OF HULKED VESSELS ON THE SOUTHERN SHORE OF FORTON LAKE. THE AERIAL PHOTO DATES FROM JUNE 2013.

The remains of FL7 are located on the southern side of Forton Lake, at the western end of the main surviving concentration of hulked vessels (Figure 2). It comprises the rusting, degraded and partially buried remnants of a First World War steam Pinnacle (No. 704) that was originally ordered in 1915, delivered in 1917, and eventually laid up after many years of service, in 1948. Pinnacle 704 is the only vessel within the Forton Lake assemblage confirmed as being of First World War date. Initial work was conducted in September 2015 and included MAT staff and a group of volunteers.

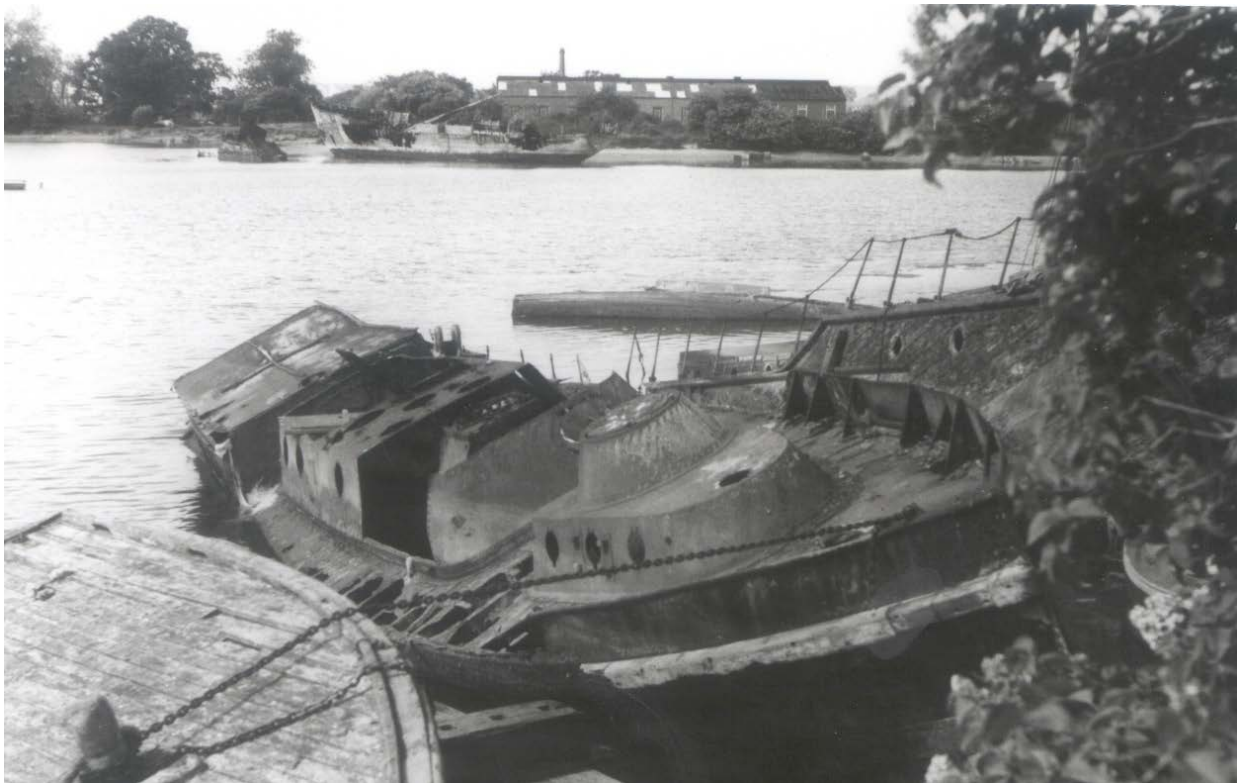
FIGURE 3: PINNACLE 704 IN THE 1970s, FROM THE JACK SMALE COLLECTION (IMAGE: COURTESY OF PHILIP SIMONS).

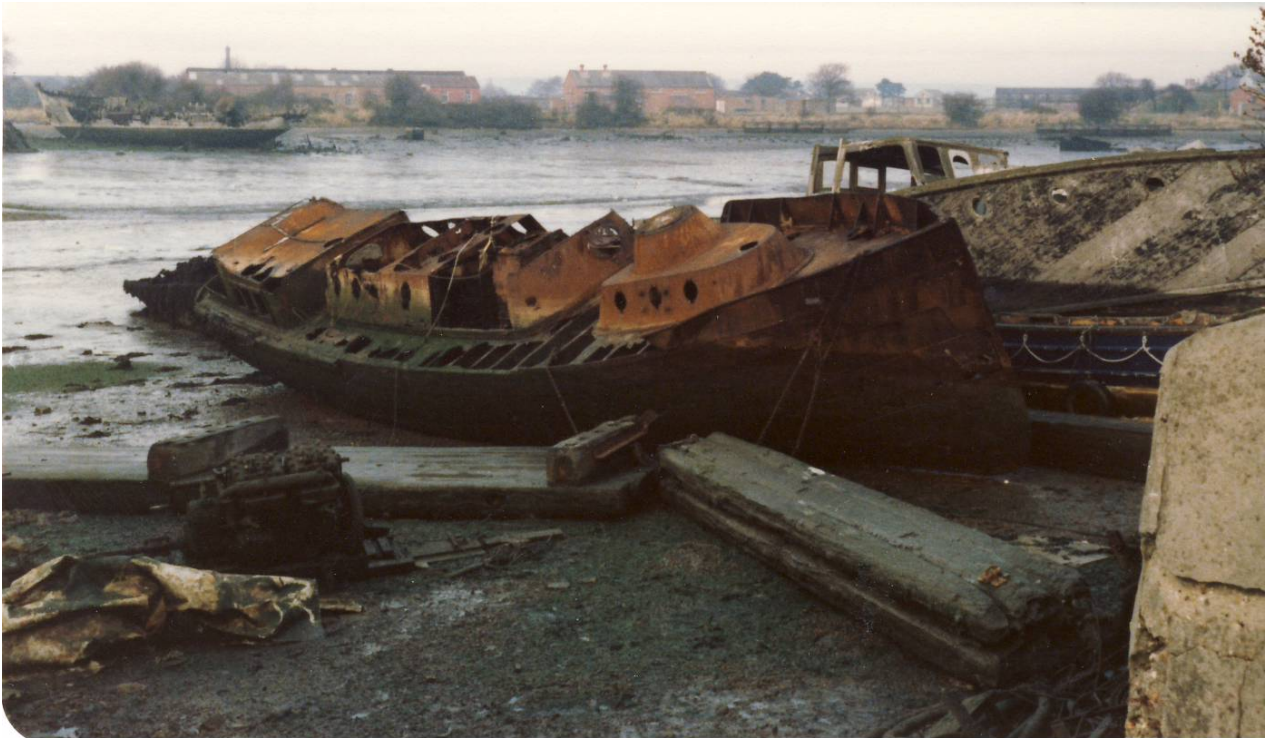
FIGURE 4: PINNACE 704 PHOTOGRAPHED AT AN UNKNOWN DATE. ASSUMED TO BE AFTER FIGURE 3 BECAUSE OF THE ABSENCE OF THE STARBOARD RUBBING STRAKE, AND CLEARLY PRIOR TO THE TRUNCATION OF THE BOW, VISIBLE IN FIGURE 5 (IMAGE: COURTESY OF PHILIP SIMONS).

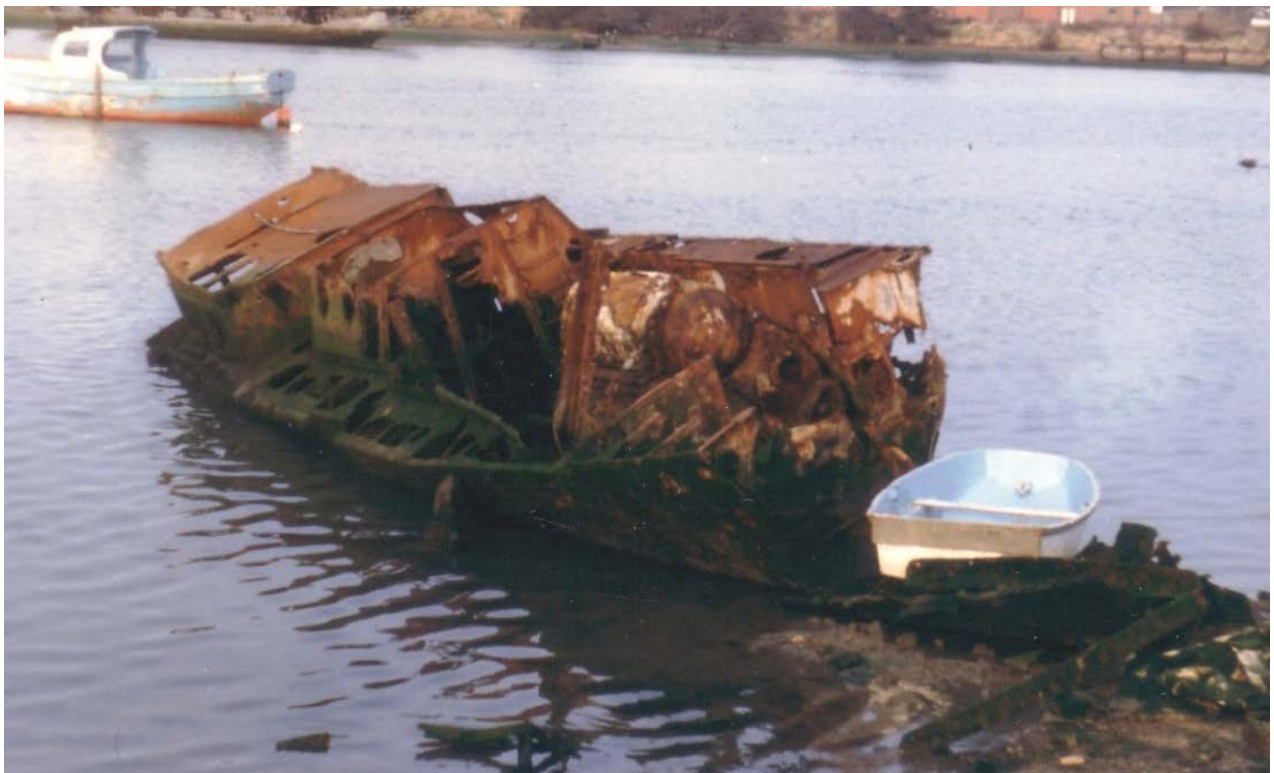
FIGURE 5: PINNACE 704 IN THE 1980s, THOUGHT TO BE 1987, WHEN THE BOW OF THE VESSEL AND GUN MOUNT HAS BEEN TRUNCATED, BUT WHERE LARGE PARTS OF THE MAIN SUPERSTRUCTURE ARE STILL IN PLACE. THE BOILER IS NOW CLEARLY VISIBLE WITHIN THE FORWARD PART OF THE VESSEL (IMAGE: COURTESY OF PHILIP SIMONS).

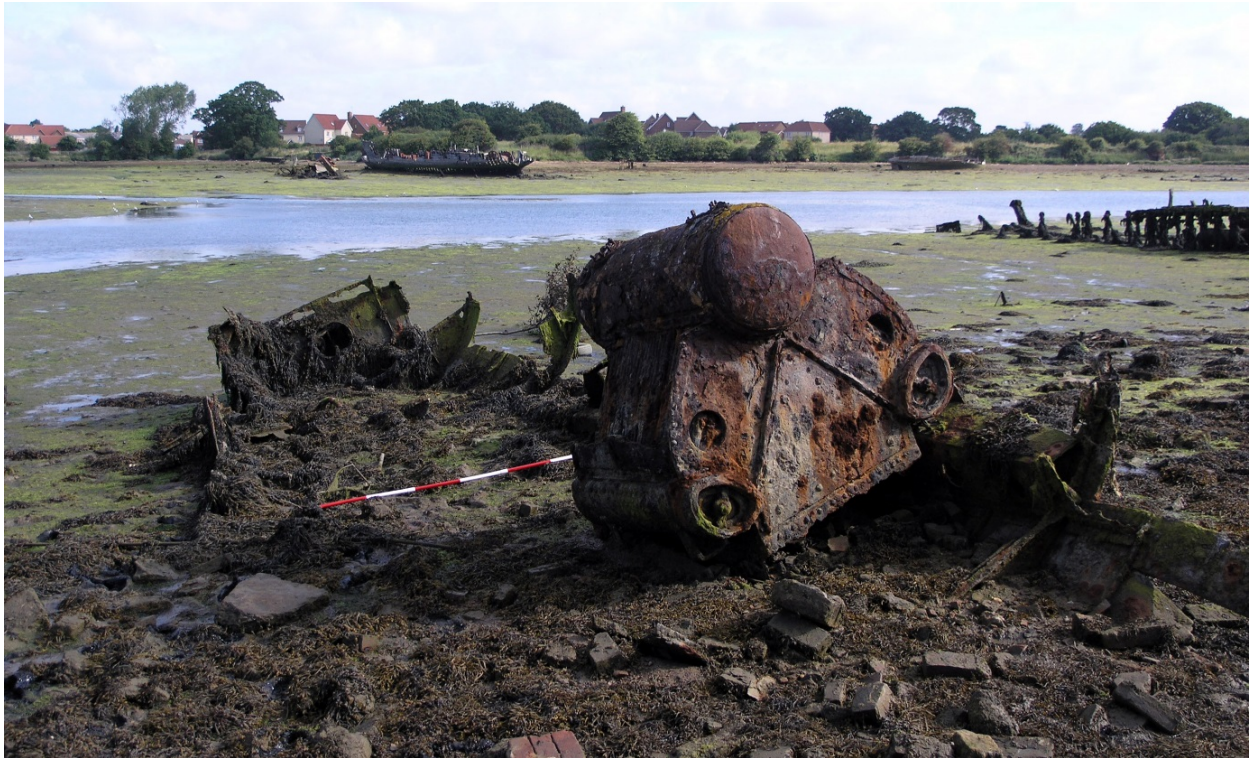
FIGURE 6: PINNACE 704 PHOTOGRAPHED IN 2006 DURING THE FORTON LAKE PROJECT. THE MAJORITY OF THE SUPERSTRUCTURE AND HULL IS NOW LOST AND THE BOILER IS THE MOST PROMINENT FEATURE OF THE SITE (IMAGE: FORTON LAKE PROJECT ARCHIVE).

Images taken in 2006 and 2015 show that sediment has been lost around the mid-section which is close to the high water mark. The tidal cycle creates slight scour where water flows freely through the

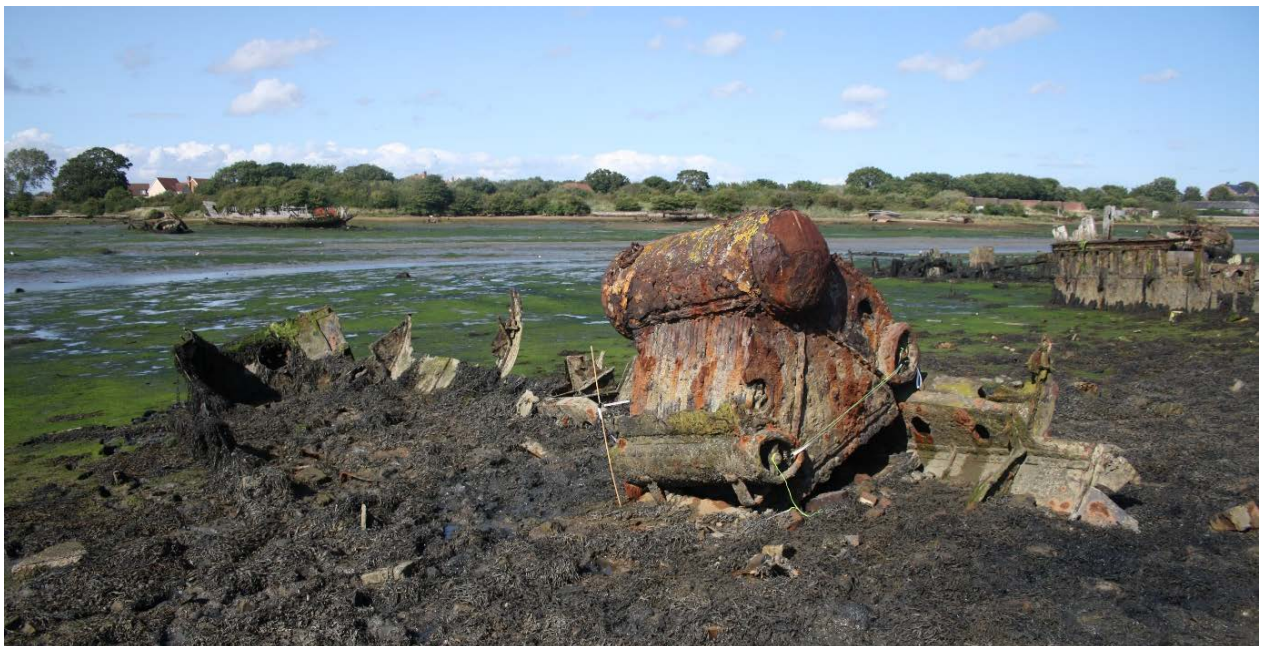
FIGURE 7: PINNACE 704 PHOTOGRAPHED IN 2015. THE OVERALL DISPOSITION OF THE SITE IS VERY SIMILAR TO ITS SITUATION IN 2006.

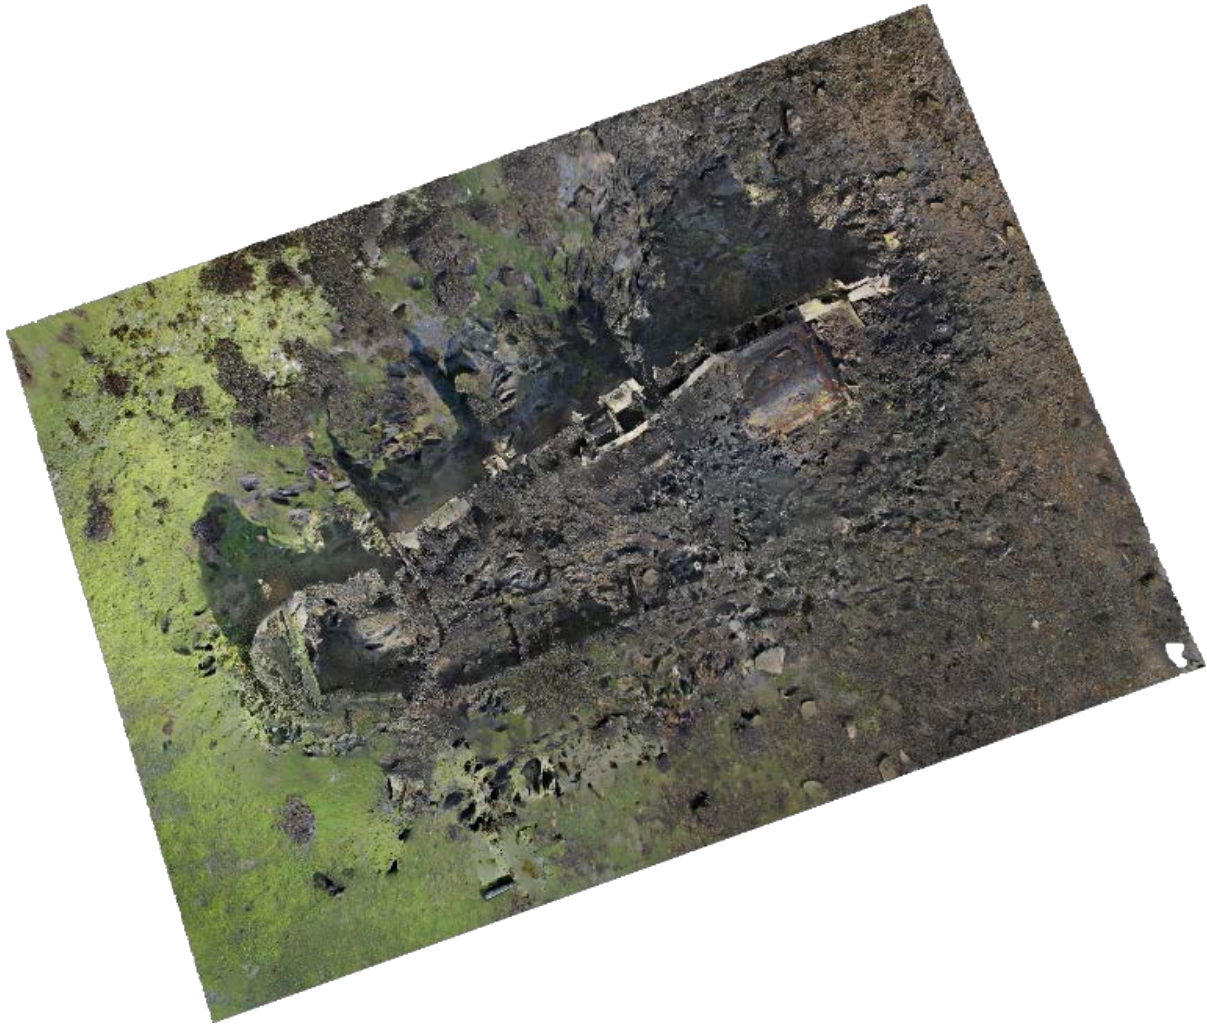
FIGURE 9: ORTHO- MOSAIC OF THE FL7 SITE.

The ortho mosaic was placed as a bitmap at a 1:1 scale in CAD software. The use of an ortho rectified image allows accurate measurements to be collected in addition to the creation of a conventional site plan that can be compared to the 2006 survey (See Figures 10 and 11). By comparing the two plans, it is clear there has been some loss of sediment on the site with new areas of structure revealed, however the 2017 plan shows the initial 2006 plan to be a highly accurate record of the site.

The model was then further refined and scaled to be analysed through CAD software to produce a number of other outputs. Through the application of this rapid field recording method an ortho-rectified overhead view of the site was generated (Figure 9 – Ortho- mosaic of site).
